**EMERGENCY SPILLWAY PERFORMANCE,
UPPER RED ROCK CREEK WATERSHED,
OKLAHOMA**

ARS-S-108

May 1976

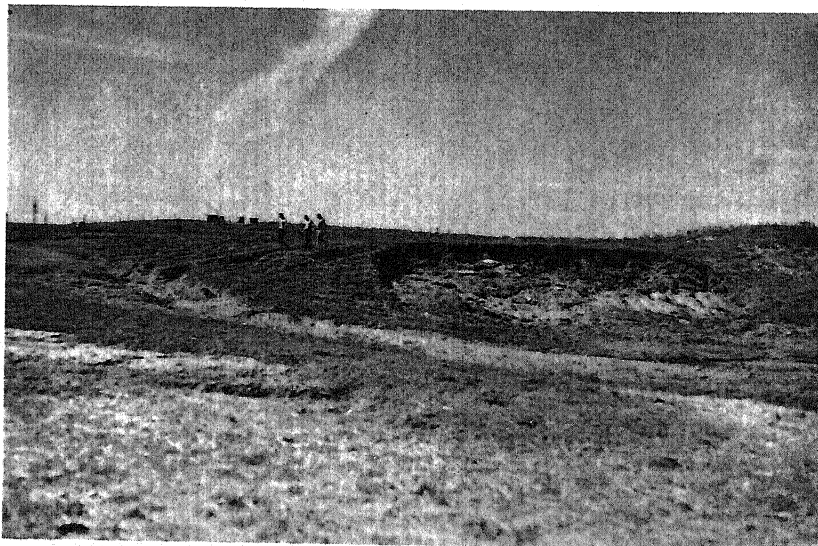
FIGURE 3.—Outlet end of site 24 emergency spillway after flood of October 10-11, 1973.

upon which the spillway discharges. The badly scoured portion to the right is on the bank of a natural channel or gully alongside the emergency spillway and was attacked by overflow from the spillway. Figure 4 shows the rills in the lower end of the spillway.

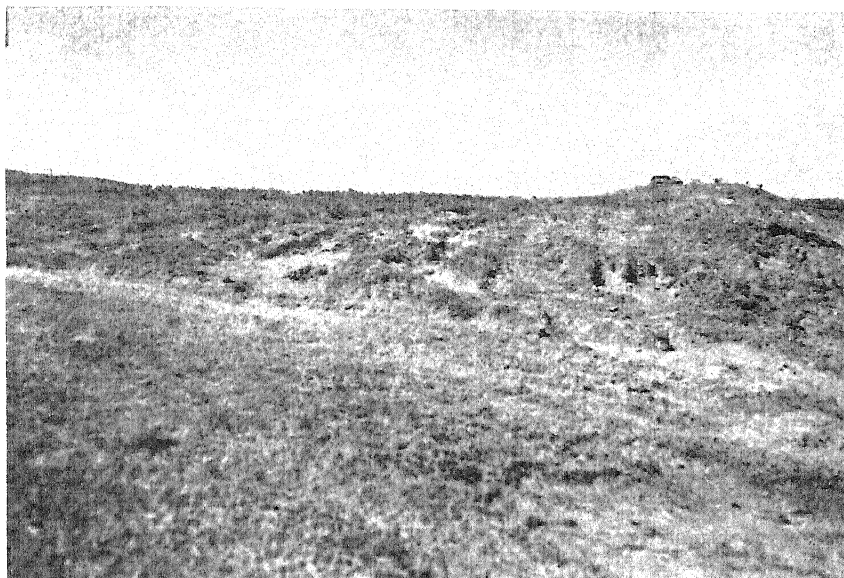
FIGURE 4.—Lower end of site 24 emergency spillway after flood of October 10-11, 1973.

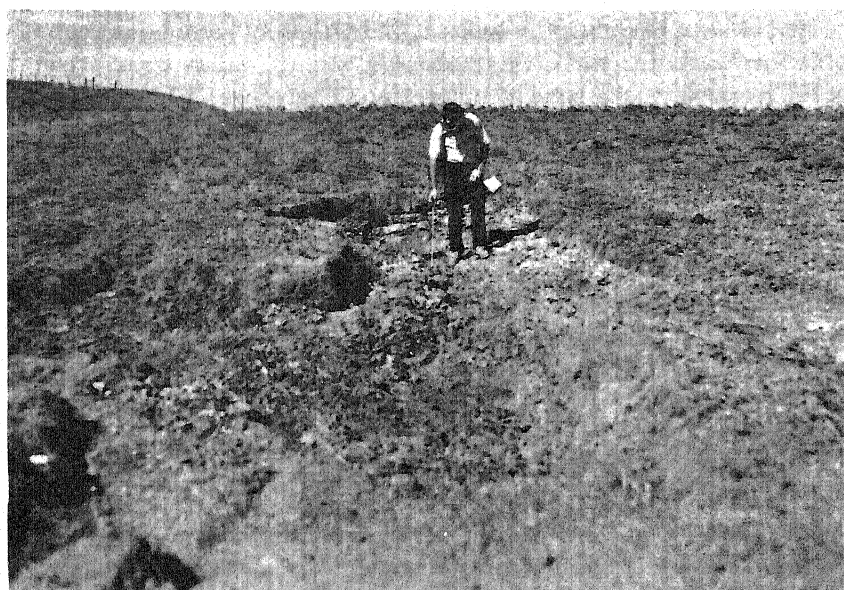
FIGURE 5.—Two-foot scour to the shale bedrock 90 feet downstream from site 24 spillway crest.

Figure 5 is a closeup view of the head of one of the deeper rills. The scour here is about 2 feet deep and extends to the shale bedrock. This part of the spillway was subjected to the 6.7 feet per second flow velocity. Immediately downstream of the spillway crest is a small area scoured to a depth of 5 inches (fig. 6).

The site 24 spillway started to erode during a flow event which had a peak mean velocity of 6.7 feet per second. The spillway appeared to have been heavily grazed, and this may have been responsible for its condition. Cattle trails and “stomp” areas were present in the spillway at the time of inspection. Therefore, it is reasonable to assume that the eroded areas also had suffered from similar cattle activity.

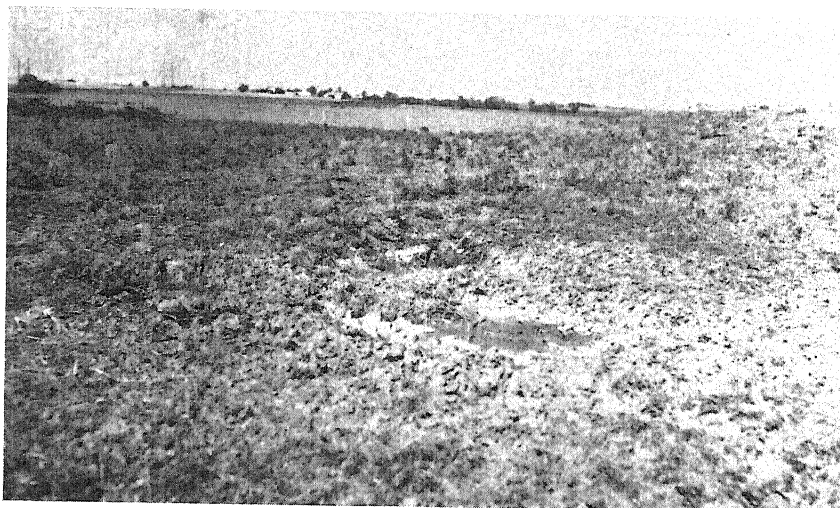
FIGURE 6.—Scoured area in site 24 spillway just downstream from spillway crest. The cover on the adjoining area is thin, poor, and short.

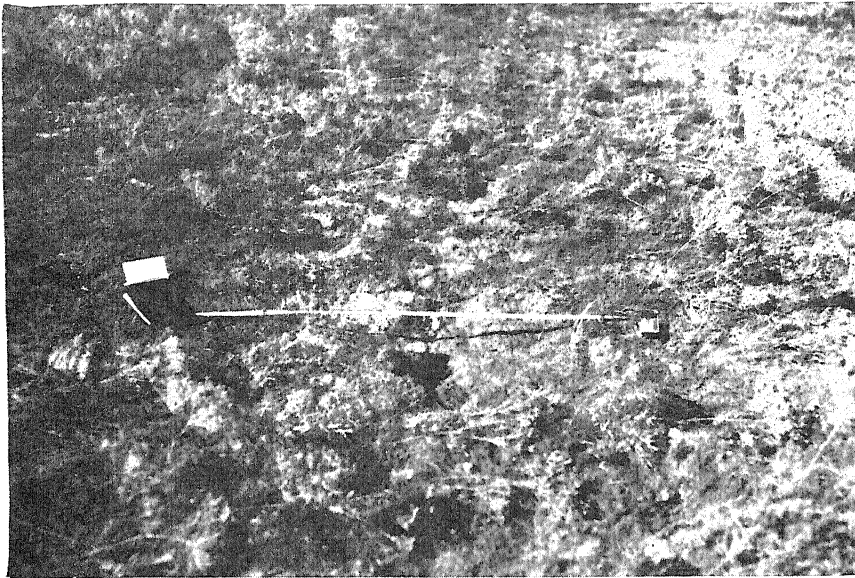
The spillway was in excellent condition after the flood. Some slight erosion was evident about 20 feet downstream from the crest and about 40 feet in from the right bank (fig. 8). It is not known whether this eroded area was present before the flood or whether there had been a weak spot in the cover here. An overall view of the spillway is shown in figure 9.

FIGURE 8.—Closeup of most eroded portion of site 25 emergency spillway after flow event of October 10–11, 1973. This point in the spillway is located approximately 20 feet downstream from the crest and about 40 feet in from the right bank. There appears to be more broomweed here, which may be a weaker cover in this area. Its appearance before the flood is not known.

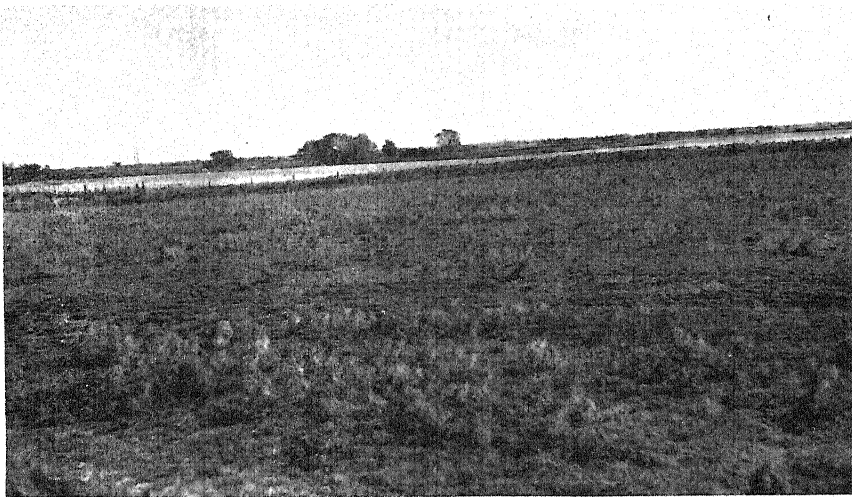
The excellent condition of the spillway should be expected because the flow velocity of 5.6 feet per second is below a suggested permissible velocity of 8 feet per second for a bermudagrass cover on clay soil and slopes of less than 5 percent, as determined from the "Handbook of Channel Design for Soil and Water Conservation" (cited in footnote 2). Uniformity of cross section and cover and moderate grazing can also be given some credit for the fine performance of the spillway.

FIGURE 9.—Overall view of site 25 emergency spillway after flow event of October 10–11, 1973. This spillway is in excellent condition. The cover is closely grazed bermudagrass, with a scattering of broomweed and some small, fine-leaved grass.

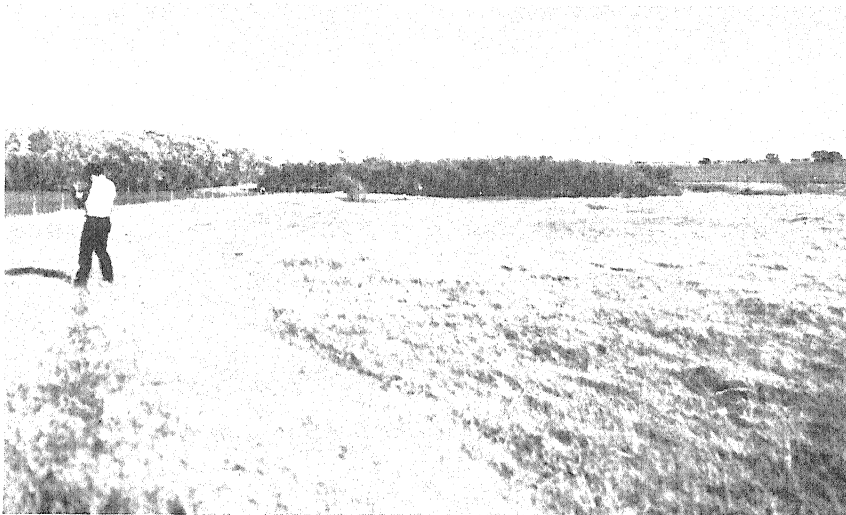
The flow velocity in the upper part of the spillway was estimated to have been 1.0 feet per second at the peak of the flood. This low velocity did not erode the spillway; the grass has hardly been disturbed. Figure 11 shows the crest of the spillway after the flow.

FIGURE 11.—Crest of emergency spillway, site 30. The cover is an excellent stand of bermudagrass.

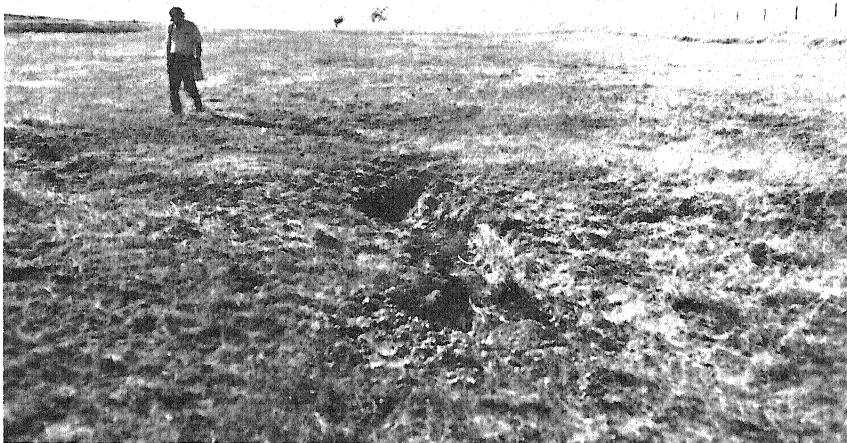
the topography of the site. A small gully has formed here (fig. 12). (It may have been there before, only to be enlarged by the flood.)

FIGURE 12.—Small gully at outlet end of site 30 emergency spillway. Concentration of flow and the poor cover may have caused this minor failure.

Second, at the outlet the spillway was gradually deepened at the centerline so it could join the existing draw in a smooth transition. The flow is concentrated at the deepest point of the spillway,

where the velocity is highest and where the gully starts. (It could eventually reach the center.) A level sill and a low drop structure at the terminal end of the spillway would eliminate the need for the deepening that threatens the stability of the spillway. This would be a practical solution only if the grass could be relied upon to provide protection against erosion in the channel upstream from the terminal structure. If the grass lining is not dependable, there would be no point in using a terminal structure because the spillway could still fail from erosion above the structure. Again, the exploration of this idea is left for future consideration.
